DELAWARE RIVER BASIN  
MINE BROOK, MORRIS COUNTY  
NEW JERSEY

# MINE HILL RESERVOIR DAM NJ 00777

PHASE 1 INSPECTION REPORT  
NATIONAL DAM SAFETY PROGRAM

REPT. NO: DAEN/NAP-53842/NJ00777-81/08  
AUGUST 1981

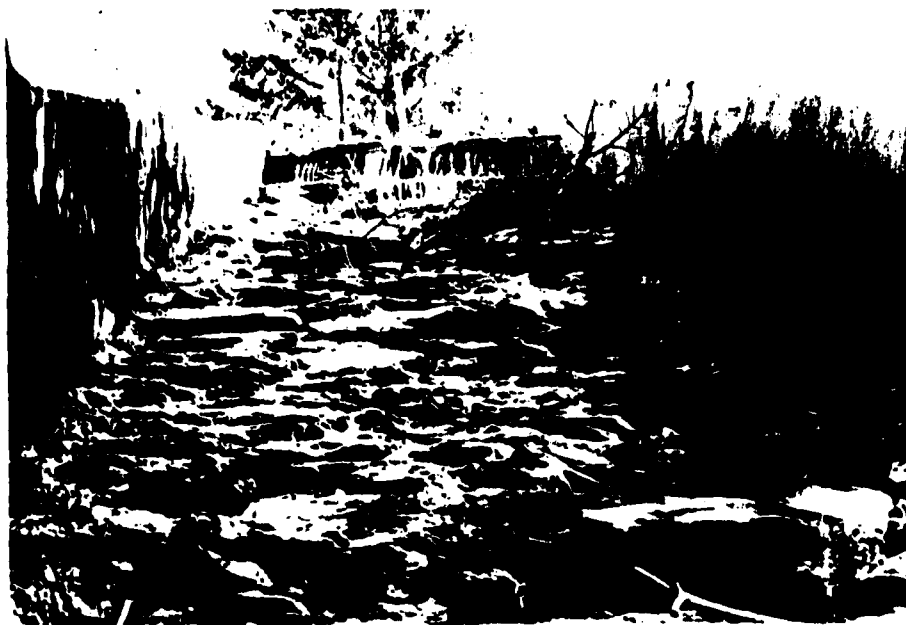
The spillway channel walls on both sides, upstream and downstream of the stoplogs, are generally cracked and spalled. Continuous undermining of the concrete walls at the base was observed. The bottom of the channel is open stone which permits discharge water to infiltrate. The wooden stoplogs are badly deflected and the center support is bent.

View looking u/s in spillway channel.

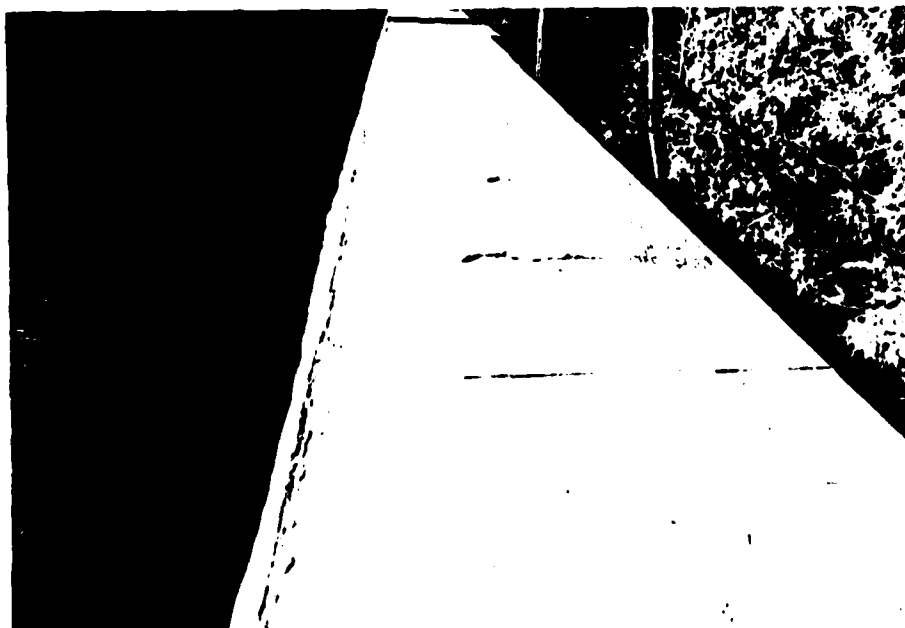
Looking along axis of dam crest from the right (north).

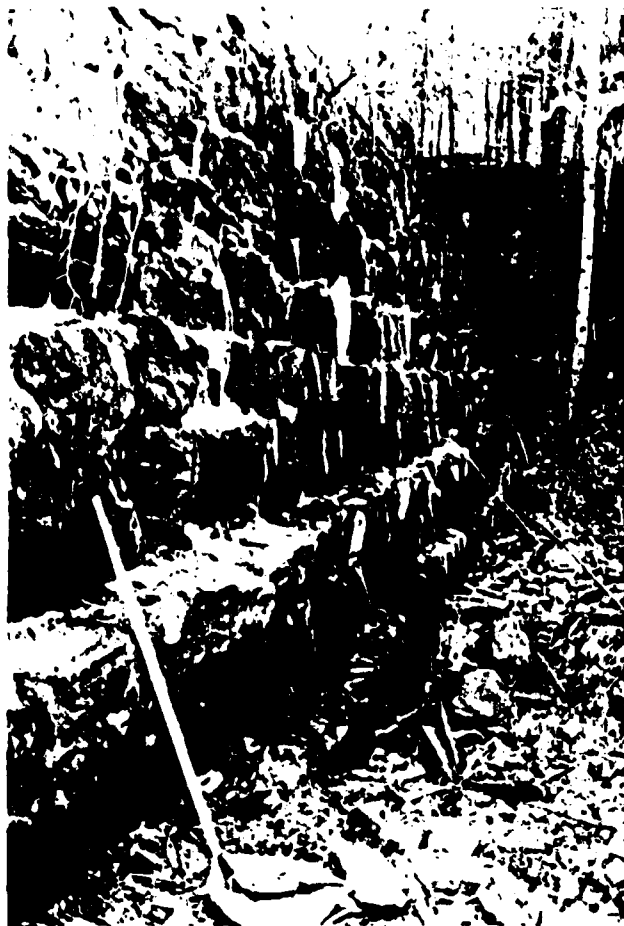
Minor seepage is occurring at the contact of the masonry dam and the left rock abutment could result in failure of the dam, if not controlled. Because of freezing and thawing action, such seepage, if not controlled, could result in a serious problem.

View of d/s face of dam looking toward left abutment contact with natural rock face. Note seepage through masonry on face below spillway notch.

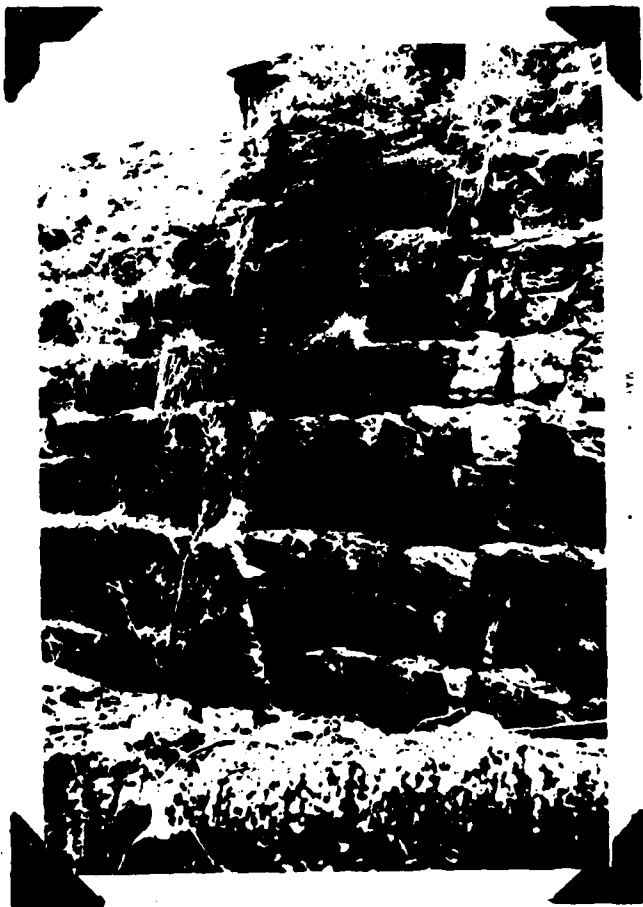
Downstream face of center dam  
(Emergency spillway at top of  
picture). 5/16/69
